Risk Management Assessment Report

Tully BESS QLD

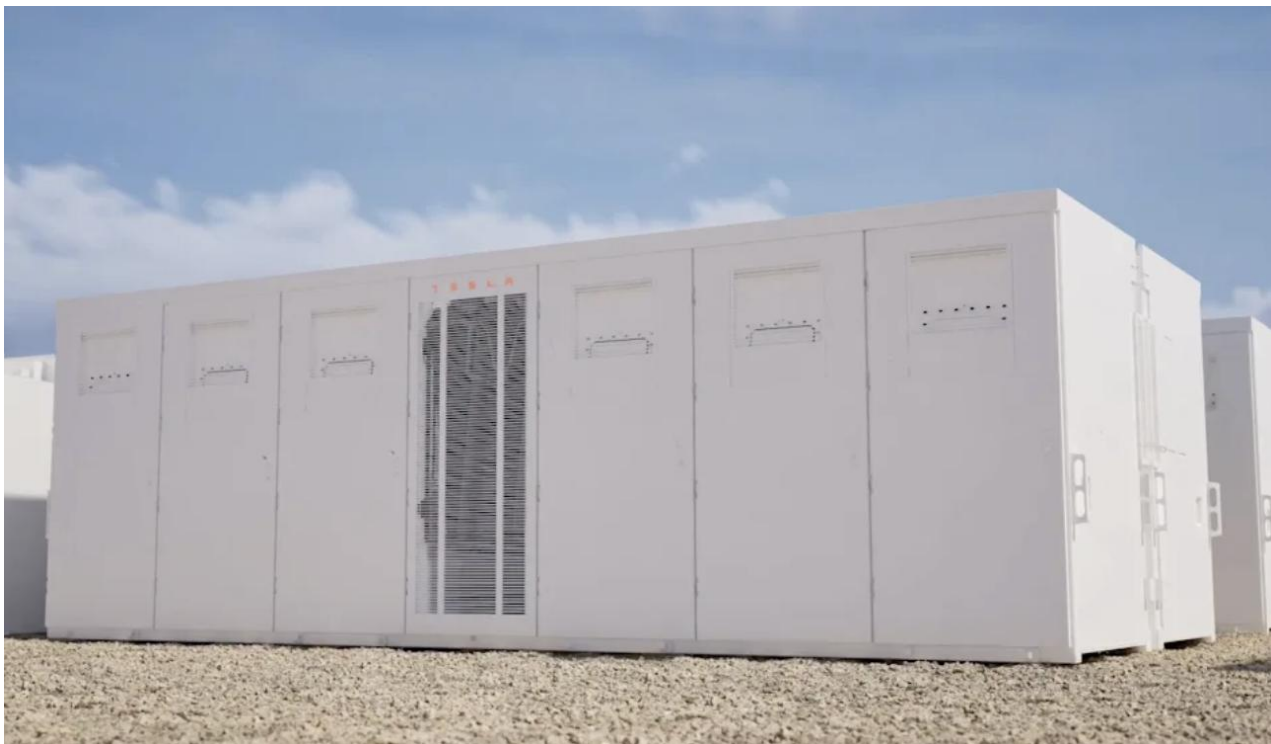
The BESS units will be located within the designated BESS area. The BESS converts electrical energy into chemical energy and stores the energy internally. The BESS model is expected to be the Megapack 3 which is shown in **Figure 3-4**.

Figure 3-4: Tesla Megapack 3 Model

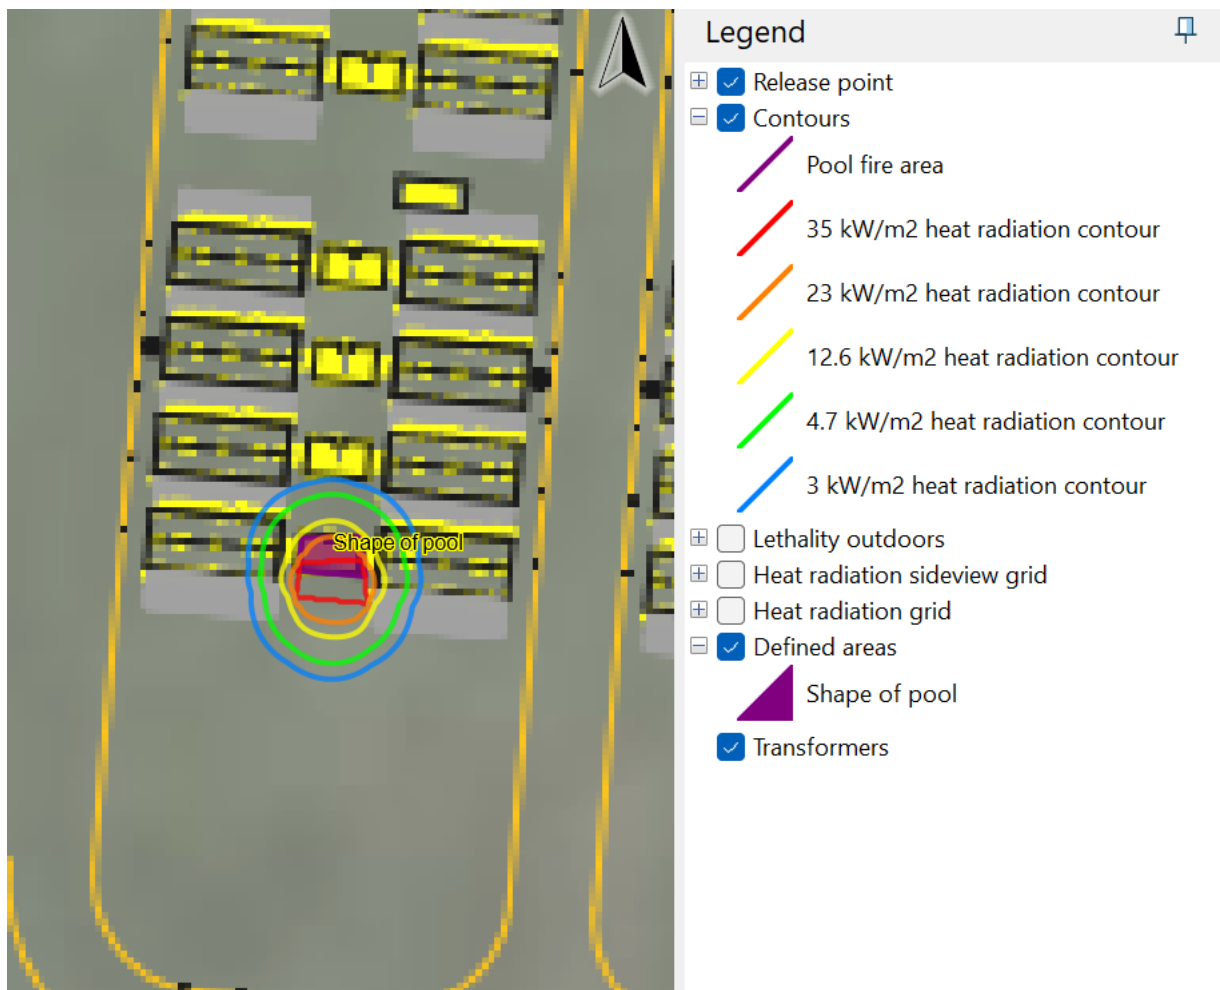
The 23 kW/m² contour has been used to assess the potential for propagation of the incident. The results in **Table 5-5** indicates the 23 kW/m² contour may impact adjacent infrastructure (other MV Transformer or adjacent BESS units) as they are within 5 m of the incident MV Transformers. However, the fire safety features inherent to the BESS units and MV Transformers are not considered in the modelling of the pool fires and make the risk of incident propagation negligible. Furthermore, **Figure 5-2** shows that the 4.7 kW/m² contours are shown not to impact the site boundary.

Figure 5-2: MV Transformer Fire Radiant Heat Contours

The 23 kW/m² contour has been used to assess the potential for propagation of the incident. The results indicate the 23 kW/m² contour may impact its own MV transformer. The consequence analysis of the MV transformer has been provided in **Figure 5-2**. The separation distance between neighbouring Megablocks is 3.0 m; hence, incident propagation is not expected to occur. Furthermore, the fire safety features inherent to the BESS units and MV Transformers are not considered in the modelling of the pool fires and make the risk of incident propagation negligible. If the layout in **Figure 3-2** is emulated in the final design, there will be no off-site impact from the 4.7 kW/m² contour.

A conservative detailed analysis has been conducted in **Appendix B** and the radiant heat impact distances estimated for this scenario are shown in **Table 5-5**. The radiant heat contours associated with a fire occurring within the MV Transformers are shown in **Figure 5-2**.

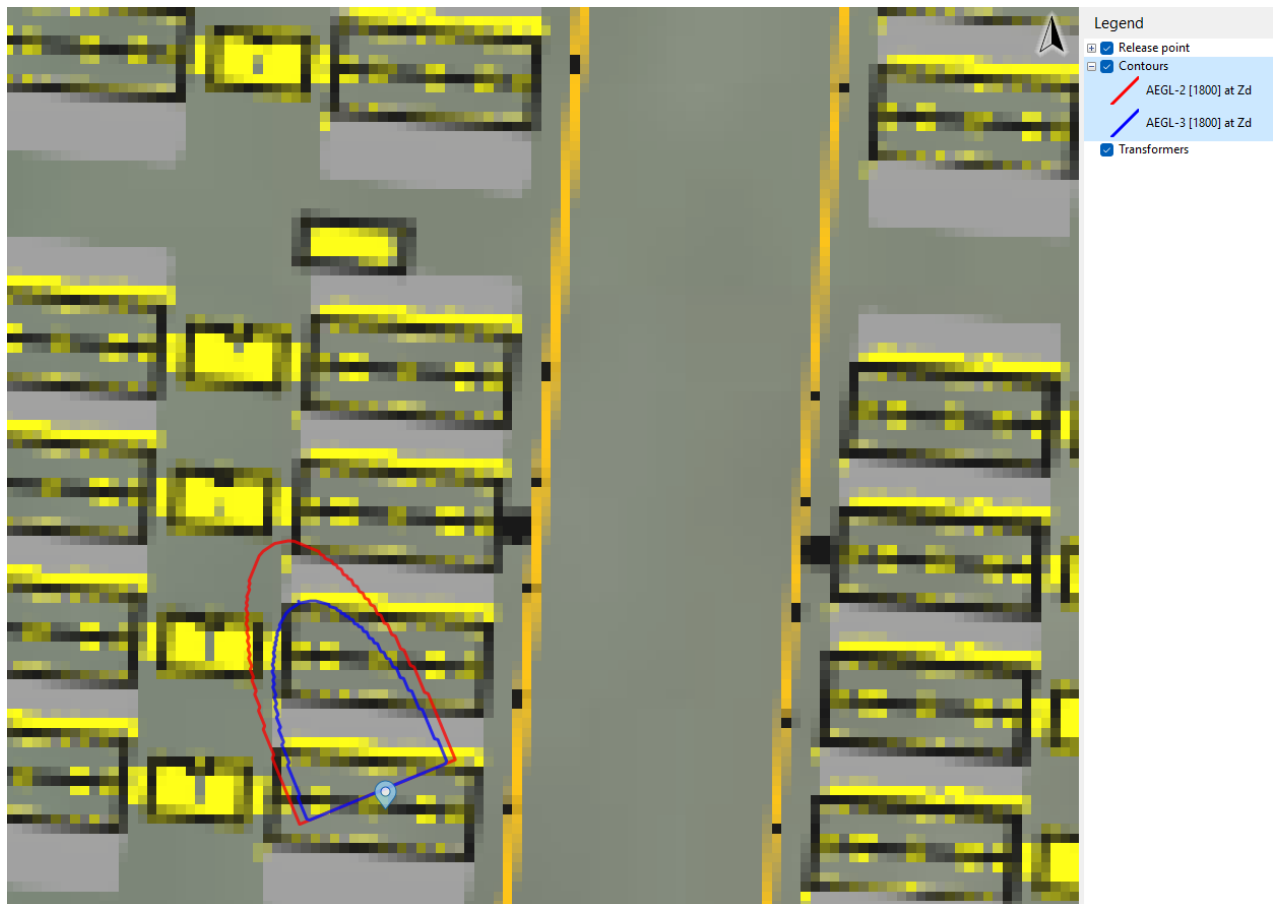
Figure 5-4: HF AEGL 5 Minute Exposure Contours Proximity to Offsite Receptors.

The modelled AEGL contours for a 5-minute exposure duration indicate that toxic impacts associated with the worst-case BESS fire scenario are highly localised and limited in extent, with AEGL-2 and AEGL-3 thresholds confined to within 14 m and 11 m of the source, respectively. These distances demonstrate that personnel are able to evacuate the immediate vicinity or reach a place of safety without significant exposure likely to result in long-term health effects, particularly given the short duration of exposure associated with movement to shelter or evacuation.

Figure 5-3 illustrates the HF plume geometry resulting from the worst-case BESS fire scenario, while **Figure 5-4** presents the spatial extent of AEGL-2 and AEGL-3 exposure zones at a received height of 1.5 m. These figures demonstrate the potential exposure of personnel during evacuation or movement to shelter, as well as the proximity of the toxic plume to external receptors.
